Information Sheet # 46
Thermal Imaging Tests on Generator Set Systems

*Your Reliable Guide for
Generator Maintenance*

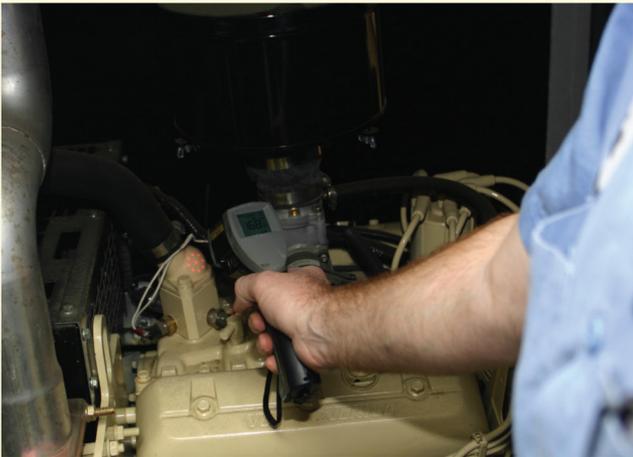
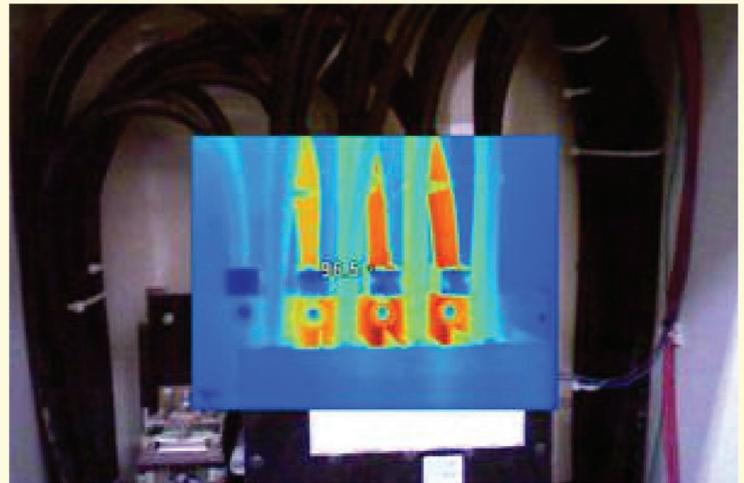
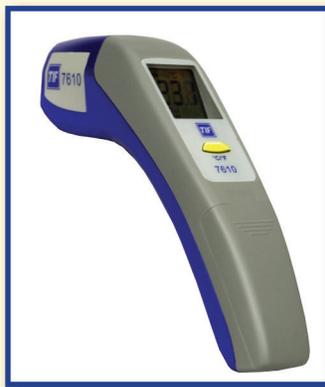
Infrared Ray Gun

Many service technicians use infrared guns, which show any such hot spots but these are unable to provide a hard copy for the record. Today's thermal imagers have ability to view live images of heat emitted from equipment and are becoming ever more affordable, making them highly practical and cost-effective.

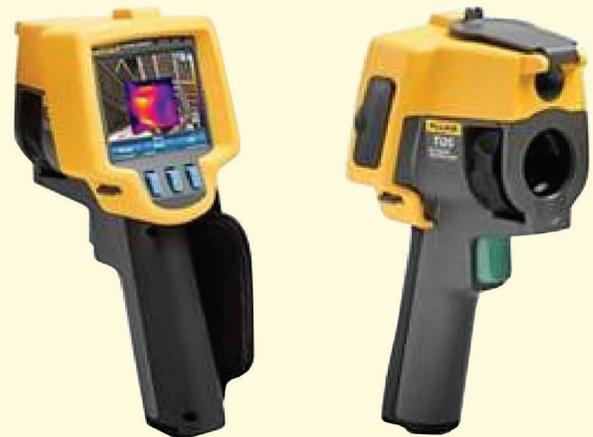
Images of an Actual Infrared Camera

The technician points the imager at the equipment in question, scans the immediate area for unexpected hot spots, then squeezes the trigger to capture a specific image. Once the inspection has been completed, the saved images can be uploaded to a computer for closer analysis, reporting or future trending. While imagers are simple to operate, they are most effectively employed when in the hands of a qualified technician, who understands electrical measurement and the equipment being inspected.
