### 1.0 INTRODUCTION

**This information sheet discusses use of thermal imaging with generator set systems.**

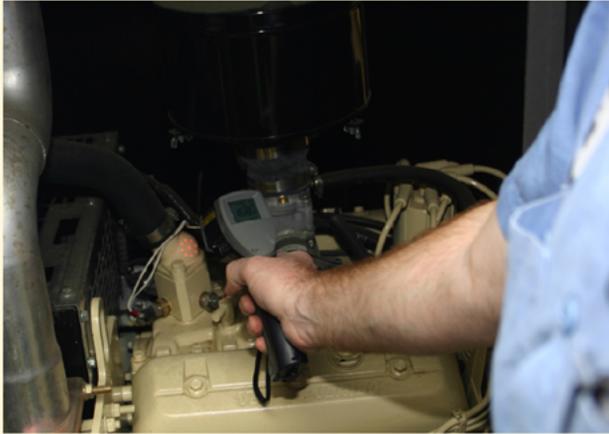
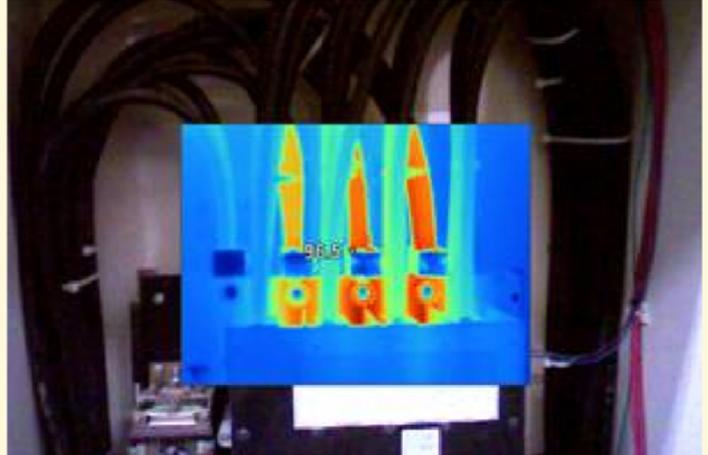
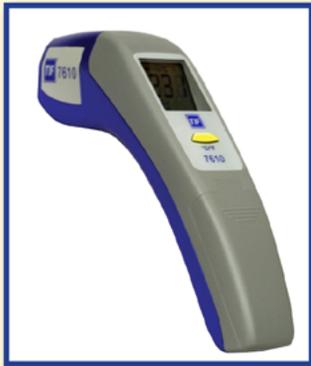
INFRARED RAY GUN

Many service technicians use infrared guns, which show any such hot spots but these are unable to provide a hard copy for the record. Today's thermal imagers have ability to view live images of heat emitted from equipment and are becoming ever more affordable, making them highly practical and cost-effective. As any bad electrical connection can generate additional heat and therefore this will reduce system efficiencies and has the potential to risk more serious damage - is the biggest cause of electrical fires. All electrical connections deteriorate over time, so thermal imaging can be utilized to detect and repair in advance so as to prevent any such failures.

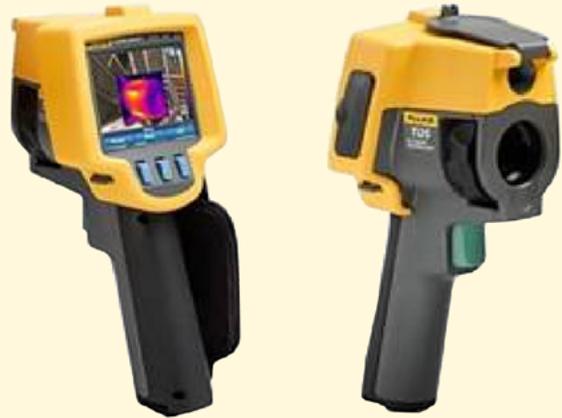
IMAGES OF AN ACTUAL INFRARED CAMERA

The technician points the imager at the equipment in question, scans the immediate area for unexpected hot spots, then squeezes the trigger to capture a specific image. Once the inspection has been completed, the saved images can be uploaded to a computer for closer analysis, reporting or future trending. While imagers are simple to operate, they are most effectively employed when in the hands of a qualified technician, who understands electrical measurement and the equipment being inspected.
